REPORT DOCUMENTATION PAGE		READ INSTRUCTIONS BEFORE COMPLETING FORM
1. REPORT NUMBER	2. GOVT. ACCESSION NO.	3. RECIPIENT'S CATALOG NUMBER
AD-A092038		
4. TITLE (and Subtitle) Phase I Inspection Report Mt. Beacon Reservoir Hudson River Basin, Dutchess County, New York Inventory No. 026		5. TYPE OF REPORT & PERIOD COVERED Phase I Inspection Report National Dam Safety Program

19. KEY WORDS (Continue on reverse side if necessary and identify by block number) Dam Safety National Dam Safety Program Visual Inspection Hydrology, Structural Stability Mt. Beacon Reservoir Dam Dutchess County Dry Brook

PHASE I INSPECTION REPORT
NATIONAL DAM SAFETY PROJECT
MOUNT BEACON RESERVOIR DAM
I.D. NO. N.Y. 26
D.E.C. NO. 537
HUDSON RIVER BASIN
DUTCHESS COUNTY, NEW YORK

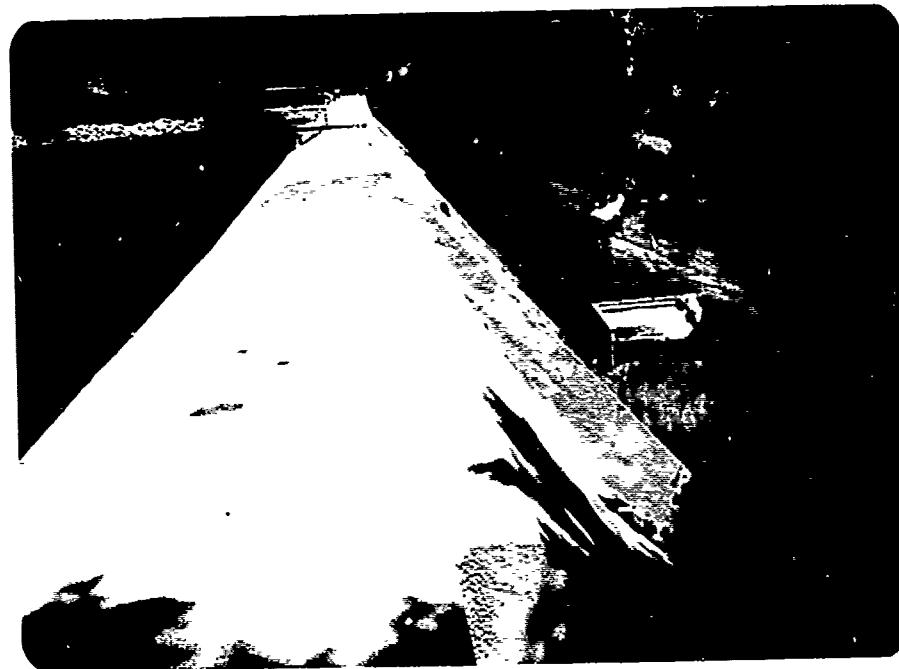
The dam is maintained by the owner. It is reported that the dam is "looked at" once a week by the owner's maintenance crew. However, maintenance of the dam is considered inadequate as evidenced by the growth of vegetation in the spillway channel; downstream from the toe of the dam; seepage at the right abutment contact and the condition of the spillway and reservoir channel walls.

3. VIEW OF SPILLWAY AND DOWNSTREAM OF DAM.
NOTE: VEGETATION AT TOE OF DAM.

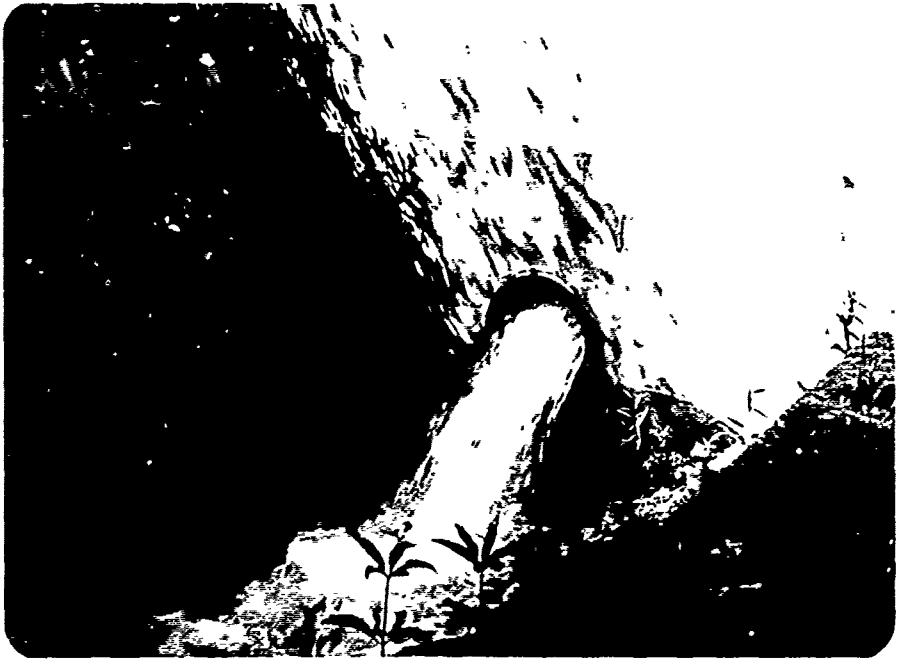
6. VIEW OF RESERVOIR DRAIN OUTLET. NOTE: 6-INCH DIAMETER PIPE NEXT TO DRAIN.
